### Repairs to Concrete Degradation

**Project:** Charles St Weir - Parramatta

**Type:** Commercial

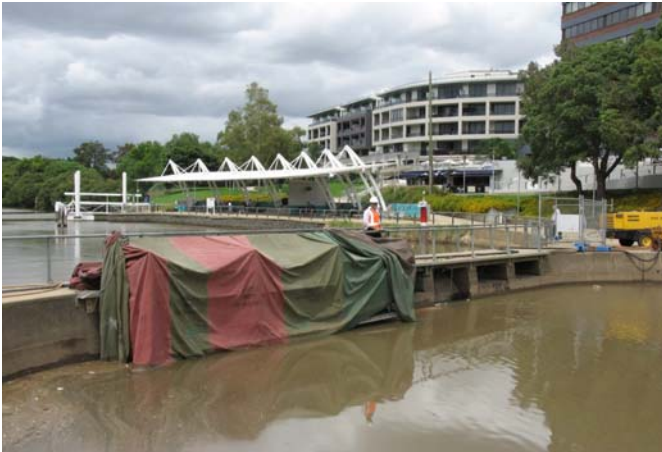
- Concrete cancer had affected the underside of the walkway to the weir and Siga was contracted to provide instructions on the rectification works.

- Determining suitable solutions and material with the builder to cater for the submerged environment that the repairs would be exposed to.
- Inspections and discussions on site to consider the heritage listing constraints as well as the builder's schedule and working conditions.
- There were 7 different sections affected. Simplifying the specifications for the works for repairs was a necessity (some sections with 100% affected soffit, others as little as 20%).

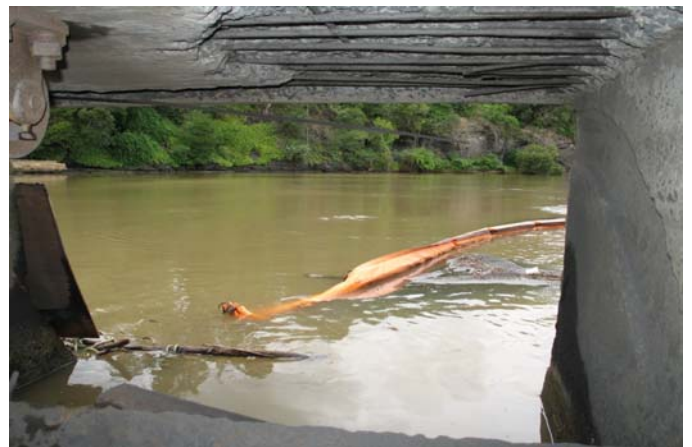
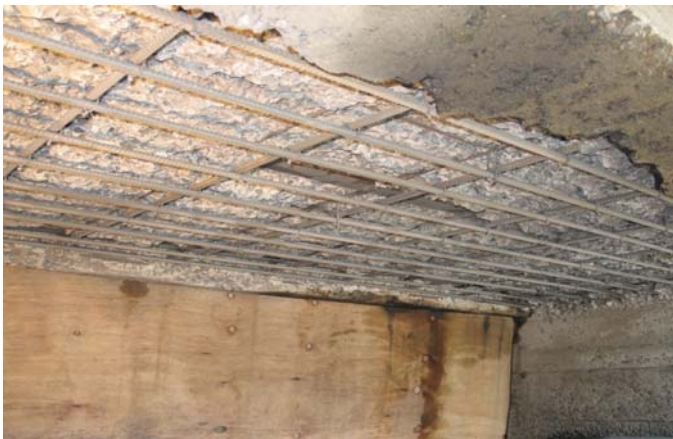
- **Pedestrian traffic:** as the walkway is heavily used by pedestrian traffic, pedestrian access of the walkway during the repairs needed to be considered.
- **Flooding:** this weir is subject to flooding when it rains! Yes, whilst it hasn't rained heavily in Sydney for some time there was some return of this rain early 2007. Of course, that's when the repairs just happened to be scheduled.
