Siga News

What's the problem?

Project: Industrial - Smithfield

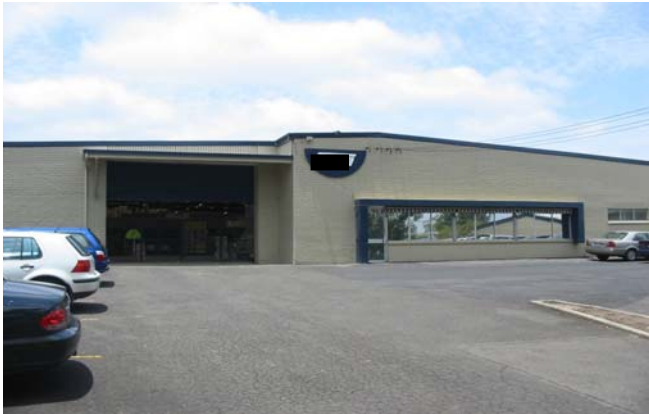
The front façade before repairs

- To determine what was causing the cracking and movement in the brickwork to the front façade and then determining whether it was from the foundation movement, wind loads, impact loads or otherwise.
- Stopping further movement and maintenance expense.
- Elimination of possible safety concerns associated with the instability.

- Priority was to stabilise the front façade to cope with normal wind loads and the loads from power lines.
- Foundation movement was considered to not be a current contributing factor to the movement.
- However, the unusual loads on the brickwork due to power lines was considered to be the main cause of the brickwork movement.
- Site inspections, supervision, issue of instructions to ensure the above structural works were conducted in accordance with our specifications.

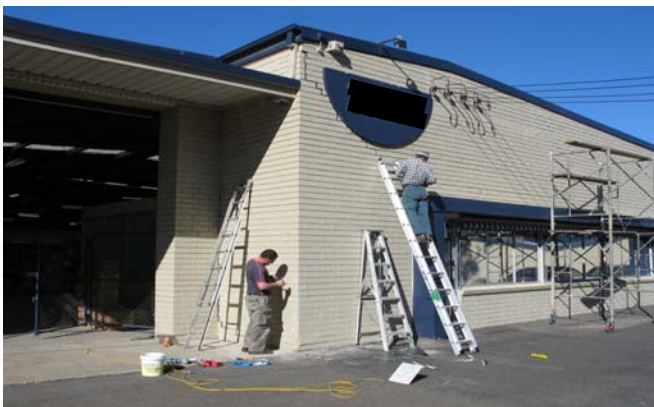
The front façade cosmetic repairs in action

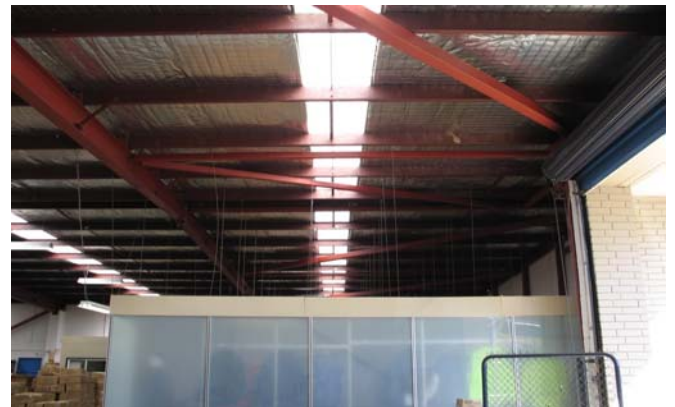
Some of the steelwork installed behind the façade
