1. Concrete Backyard Pool – Gladesville

2. Safety Rails & Ladder - Greenacre

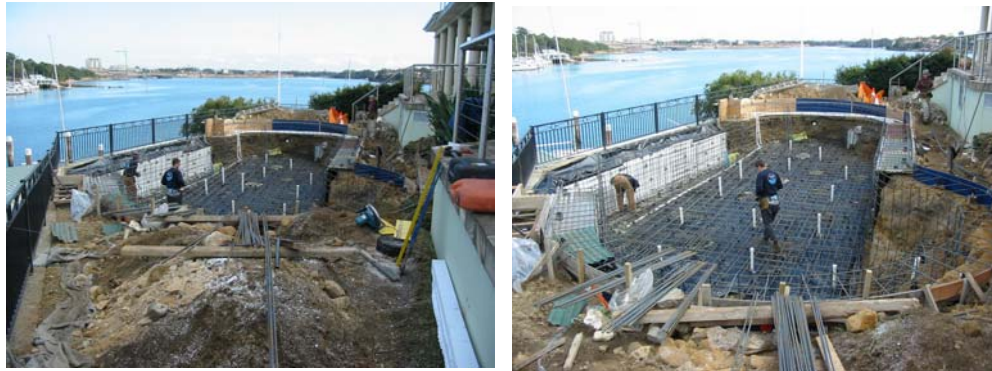
Both these photographs were taken during the inspection of the steel reinforcement. It makes a difference having good steel fixers. Rudy chose well.

- The initial design assumed clay foundations – rock was struck approximately 2 metres from the surface.
- The stability of the retaining wall around the perimeter of the pool was of concern.
- The pool had to be redesigned to accommodate the piers on the rock and a water feature.

- The original site plan and structural details of the pool for council approval.
- Subsequent updates of the design to incorporate the water feature.
- Site inspections of piers, steel reinforcement and professional advice regarding existing retaining walls.
- The redesign of the pool base to accommodate rock foundations of piers & slab.

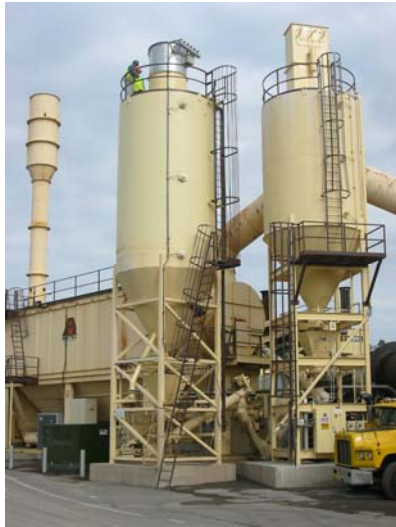
Before: This photograph was taken of the silos on our initial inspection.

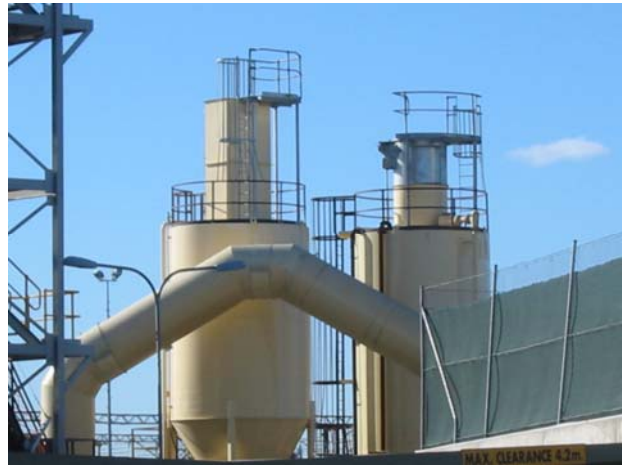
After: Safety rails, platforms and ladders were installed for maintenance access to the very top of the silos.

- ☐ Simplifying the maintenance procedure and improving safety.
- ☐ Installing safety rails, ladders and stairs in an area with many obstructions.
- ☐ Planning the details of each component to make sure that they would work easily.
- ☐ The high location meant that installation needed to be quick and efficient and that the components could be easily brought up to them.

- ☐ Initial site inspection to discuss and check proposed design loads, supports and details.
- ☐ Review of workshop details, checking for structural adequacy.
- ☐ Certification of structural adequacy of the design.
