Siga News

January – February 2009

Residential - Footing Repair

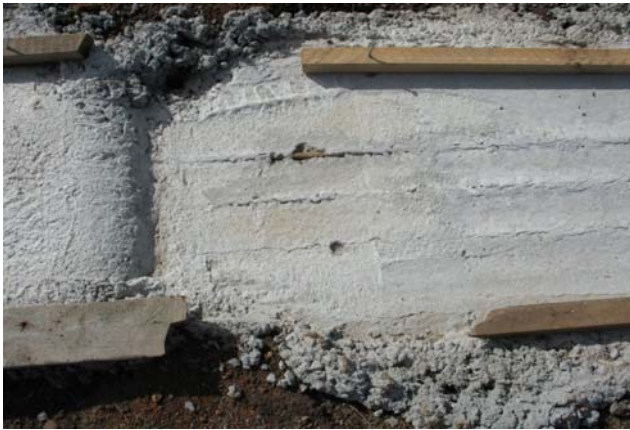
Insufficient cover

- Identifying the most suitable option to adopt for the repair.
- The footings to this project were initially poured with insufficient cover to the reinforcement.
- Due to the residence being a large single-level dwelling, the extent of insufficient cover was quite extensive.

- Topping the existing footings was deemed the most suitable solution.
- Site inspections, professional discussions, preparation of relevant structural reports.
- Documentation of remedial repair details.
- Inspections during topping pour.
- Inspection of completed works and review of concrete core results.

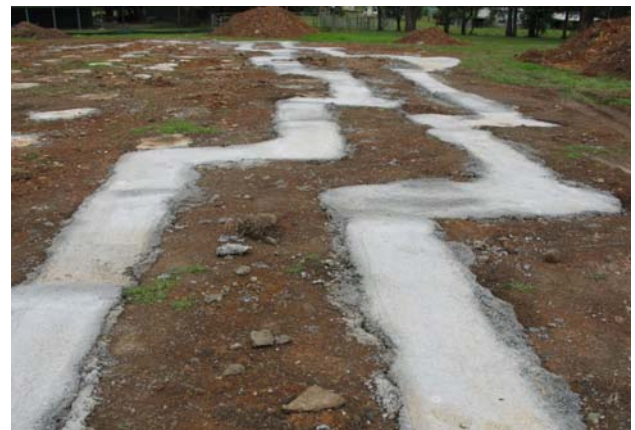
Some of the many footings to be repaired

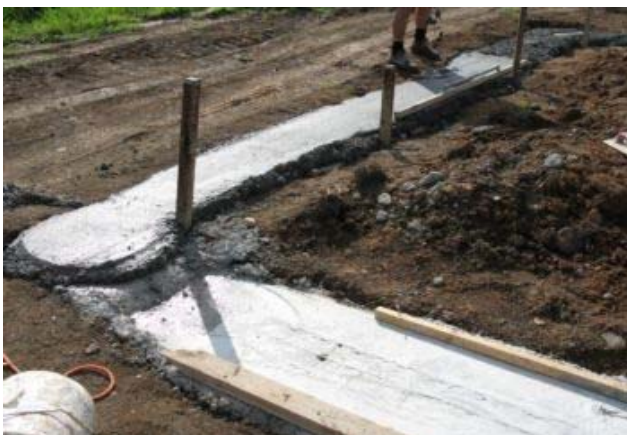
The solution
