# SIGA

May - June 2008

### Thankfully someone saw the problem

**Project: Industrial – Sydney**

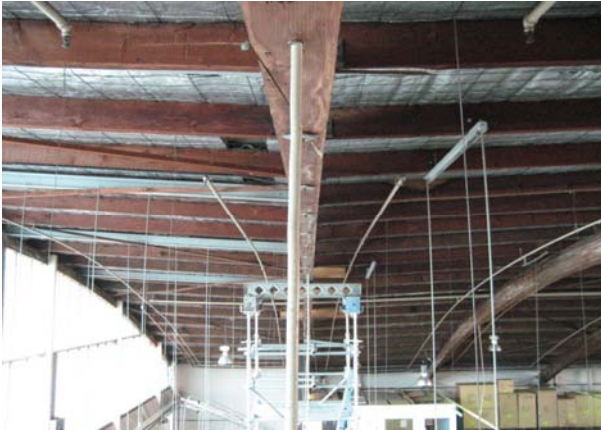
- Significant constraints such as access and air conditioning units, height of beam, existing tenants and commercial retail premises trading.
- Reinstating the beam and the building as near as possible to its intended condition whilst minimising disruption to occupants.
- This building had suffered termite damage at one end of a timber rafter spanning 40m and had shown many signs of failure.
- This beam, 10-15m above floor level and spanning 40m, had deflected far too much.

- Siga identified the initial hazard and instructed that the beam was to be made safe immediately.
- Providing a solution which was cost effective, could be implemented quickly in order to minimise disruption to tenants and suitable for the builder was imperative.
- Siga provided the documentation of final solution and necessary site supervision for its implementation, including repositioning (lifting) of beam.
