Siga News

May - June 2008

Thankfully someone saw the problem

Project: Industrial – Sydney

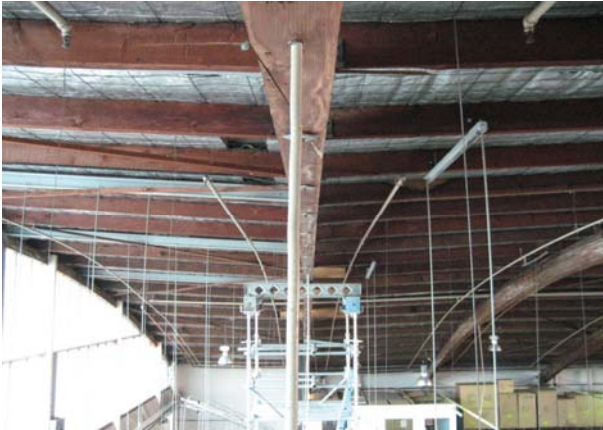
- Significant constraints such as access and air conditioning units, height of beam, existing tenants and commercial retail premises trading.
- Reinstating the beam and the building as near as possible to its intended condition whilst minimising disruption to occupants.
- This building had suffered termite damage at one end of a timber rafter spanning 40m and had shown many signs of failure.
- This beam, 10-15m above floor level and spanning 40m, had deflected far too much.

- Siga identified the initial hazard and instructed that the beam was to be made safe immediately.
- Providing a solution which was cost effective, could be implemented quickly in order to minimise disruption to tenants and suitable for the builder was imperative.
- Siga provided the documentation of final solution and necessary site supervision for its implementation, including repositioning (lifting) of beam.
